05 - STRUCTURES INDEX OF DRAWINGS

SUBSTRUCTURE CONCRETE REPAIRS IN DISTRICT 2

SUBSET COVER SHEET INDEX OF DRAWINGS-1

172-417
DRAWING NO.
S-01

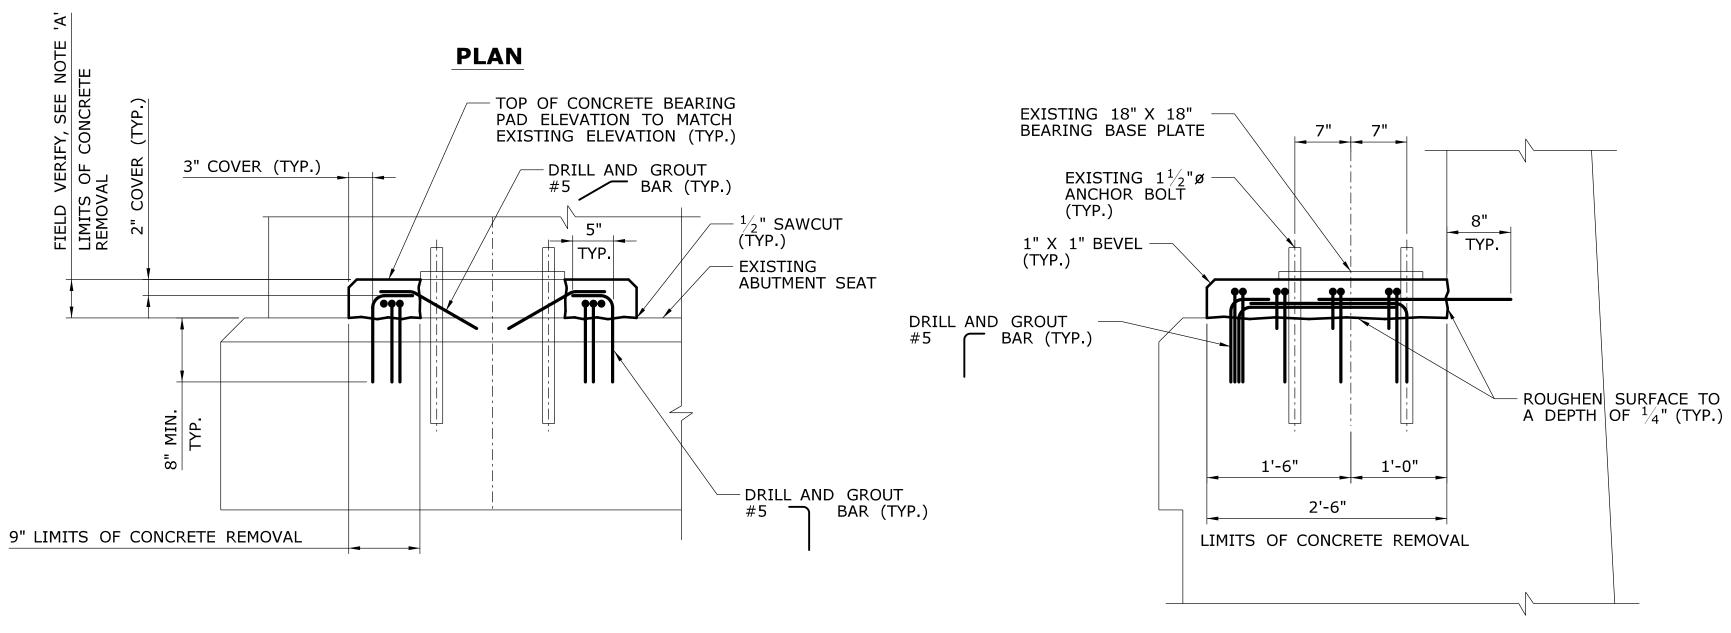
SECTION ELEVATION

NOTE: WORK SHOWN TO REPAIR THE CONCRETE MASONRY BEARING PADS SHALL BE PAID FOR UNDER THE ITEM "REPAIR OF BEARING PAD" (SEE SPECIAL PROVISION).

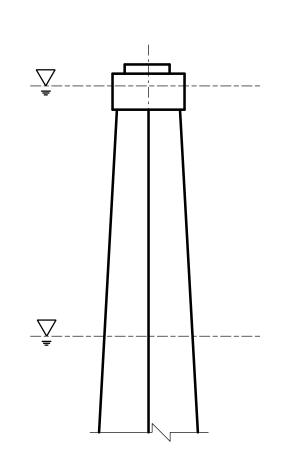
WEST ELEVATION

FULL HEIGHT X 1/4" WIDE (SEE NOTE 5) G1 G2 G3 G4 G5 1'-6" X 6" X 4" DEEP 2'-0" X 1/0" X 5" DEEP ORDINARY HIGH WATER EL. 23.0'

- 5. CRACK SHALL BE REPAIRD IN ACCORDANCE WITH "EPOXY INJECTION CRACK REPAIR" SHOWN ON DWG. NO. S-04.
- 6. MAXIMUM 15 LB PNEUMATIC HAMMER TO BE USED ADJACENT TO EXISTING REINFORCING TO REMAIN.

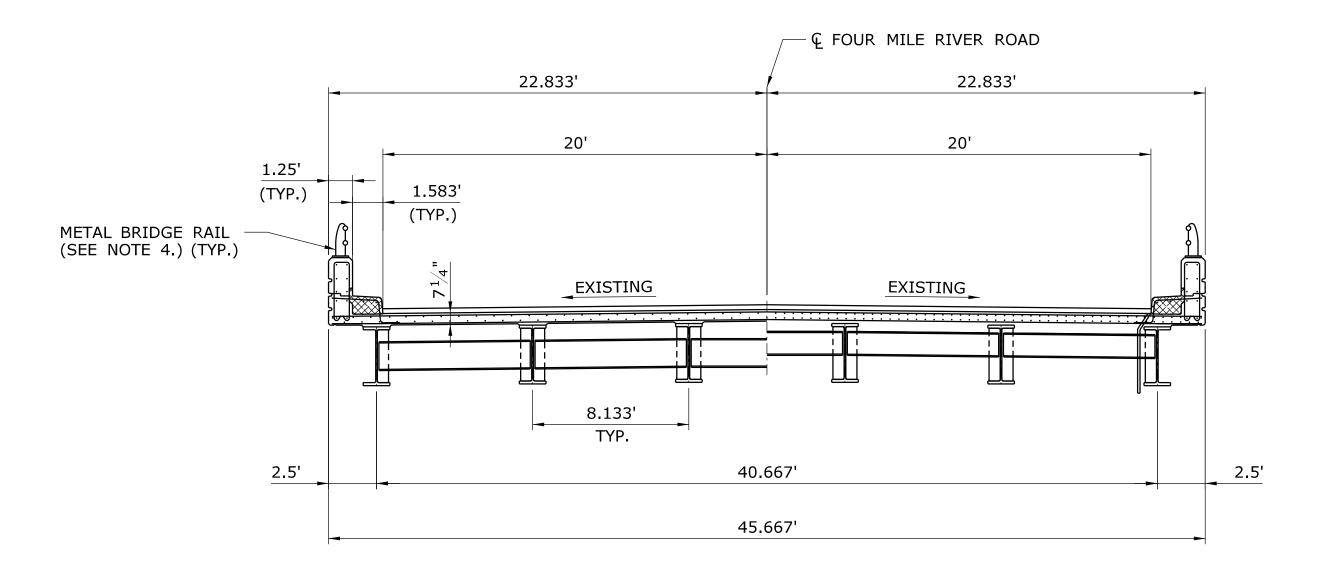
SEE TRAFFIC SHEETS FOR STAGE CONSTRUCTION MPT REQUIREMENTS

EXISTING CROSS SECTION

SCALE: 1'' = 5'

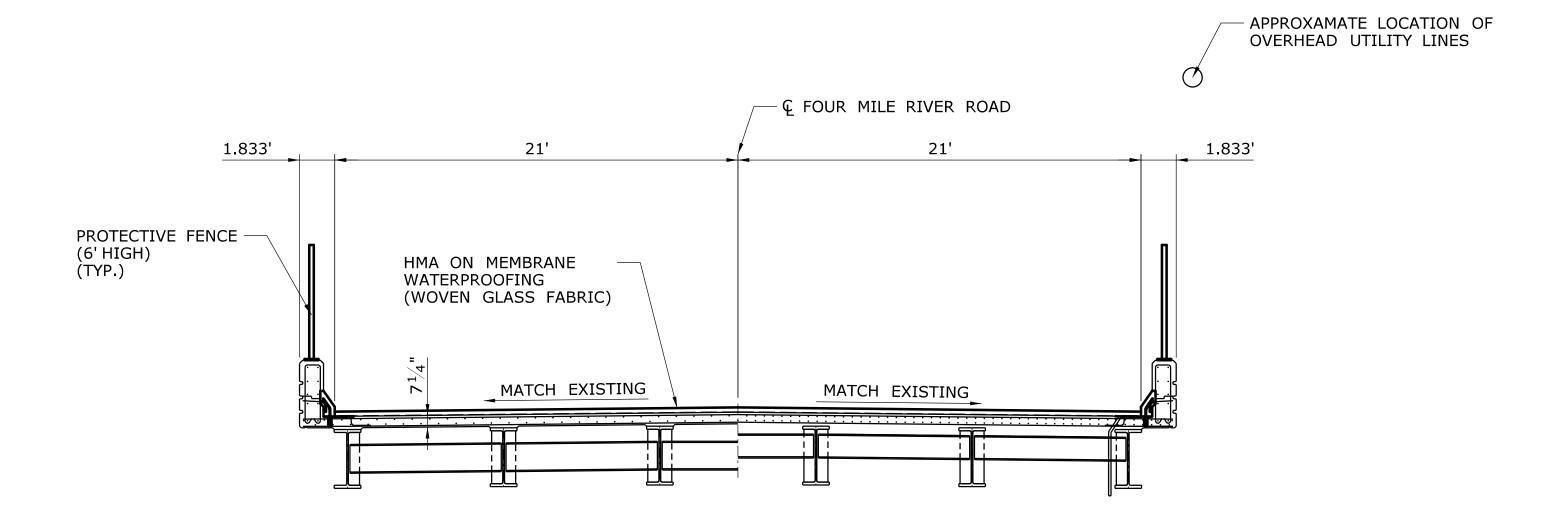
PROPOSED CROSS SECTION

SCALE: 1'' = 5'

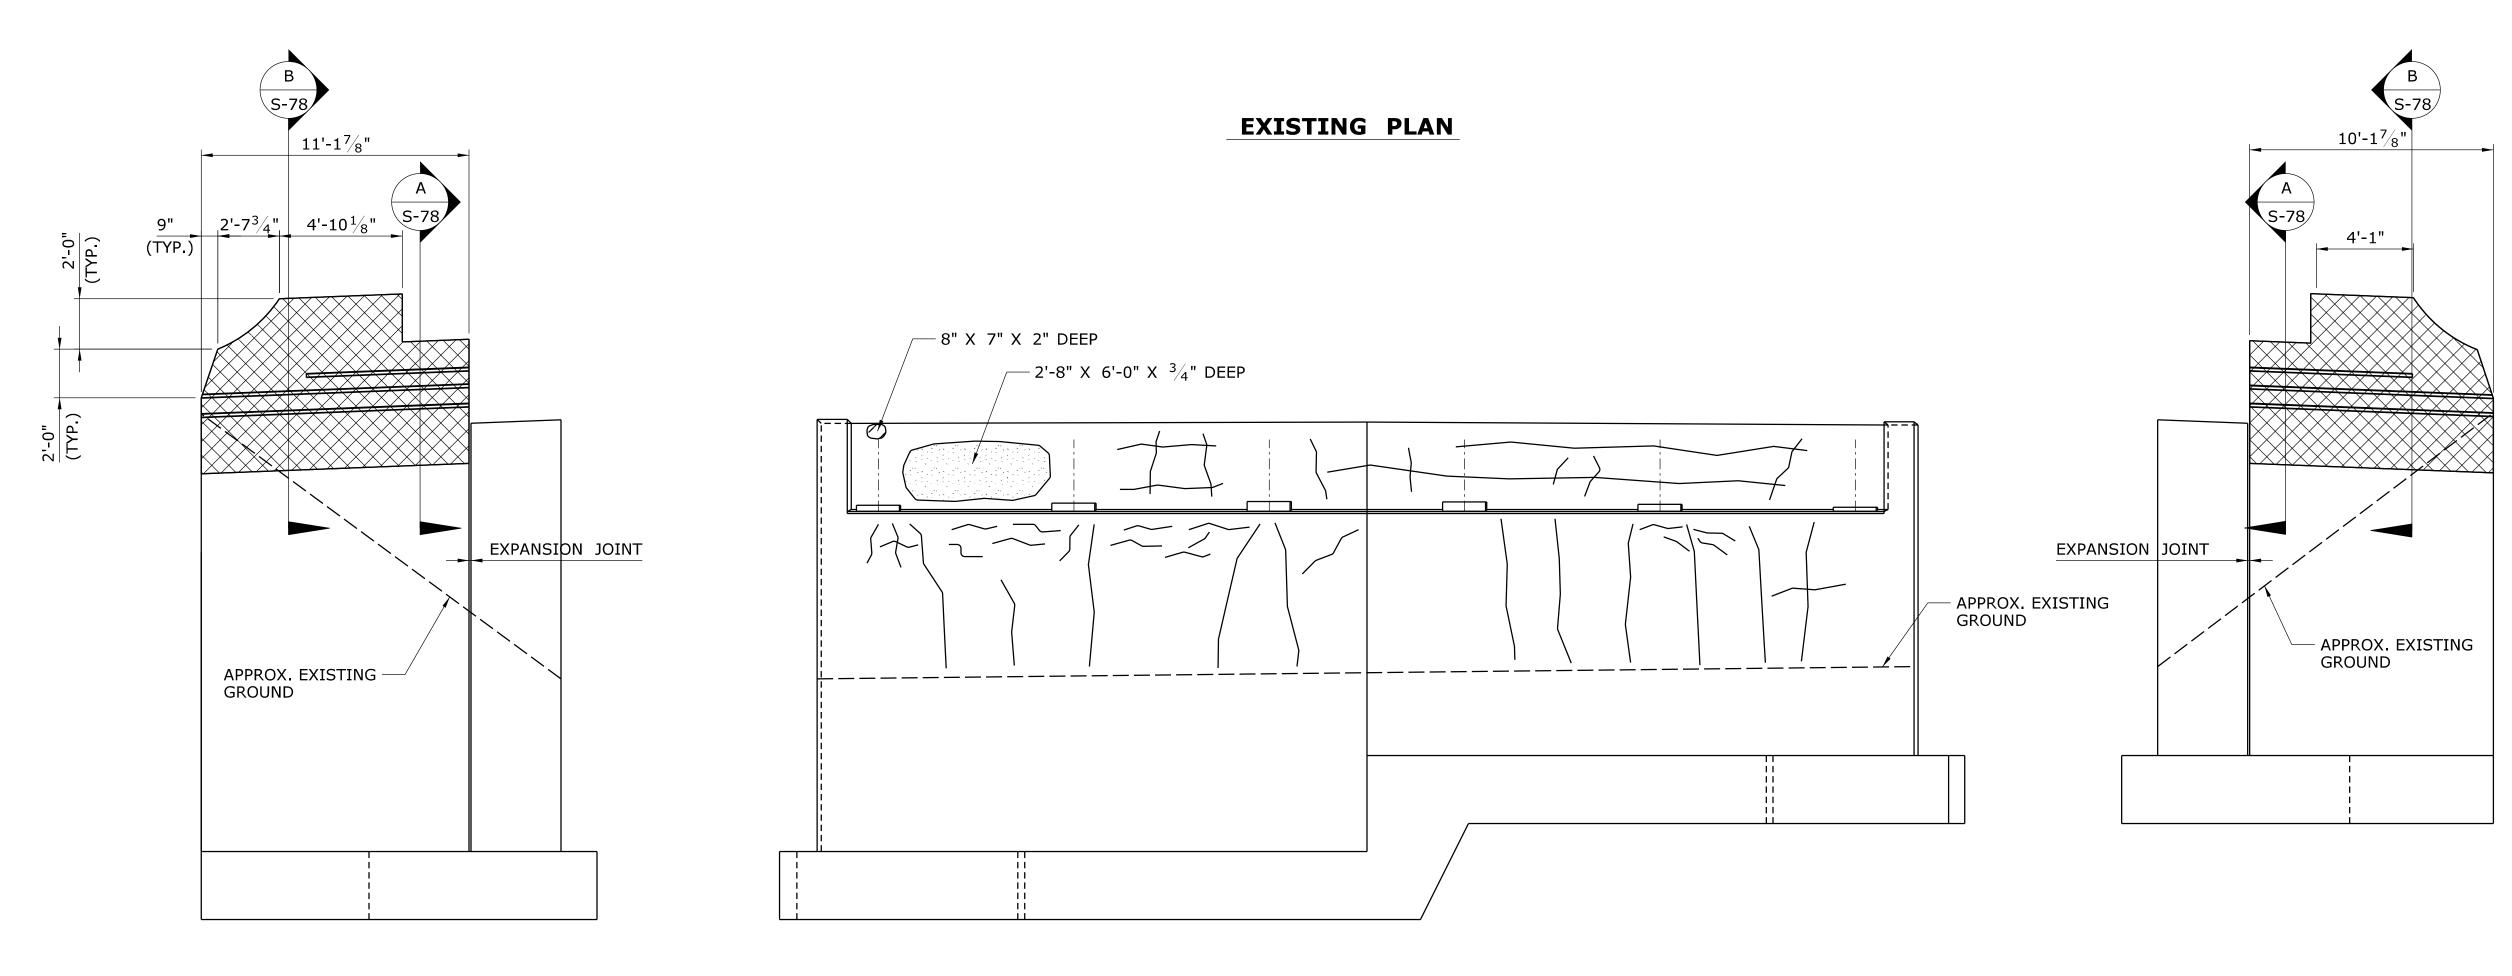
- 5. PARTIAL REMOVAL OF THE EXISTING WINGWALLS TO BE PAID FOR UNDER THE ITEM "REMOVAL OF EXISTING MASONRY".
- 6. PROVIDE A 1" SAWCUT ON ALL EXPOSED SURFACES OF THE WINGWALLS TO DELINEATE THE PORTION OF CONCRETE TO BE REMOVED. THIS WORK SHALL BE PAID FOR UNDER THE ITEM "REMOVAL OF EXISTING MASONRY".

- 7. DO NOT DAMAGE EXISTING REINFORCING STEEL TO REMAIN DURING THE REMOVAL OPERATION.
- 8. ALL EXPOSED REINFORCING INTEGRATED INTO NEW WORK SHALL BE THOROUGHLY CLEANED PRIOR TO PLACEMENT OF NEW CONCRETE.

EXISTING ELEVATION

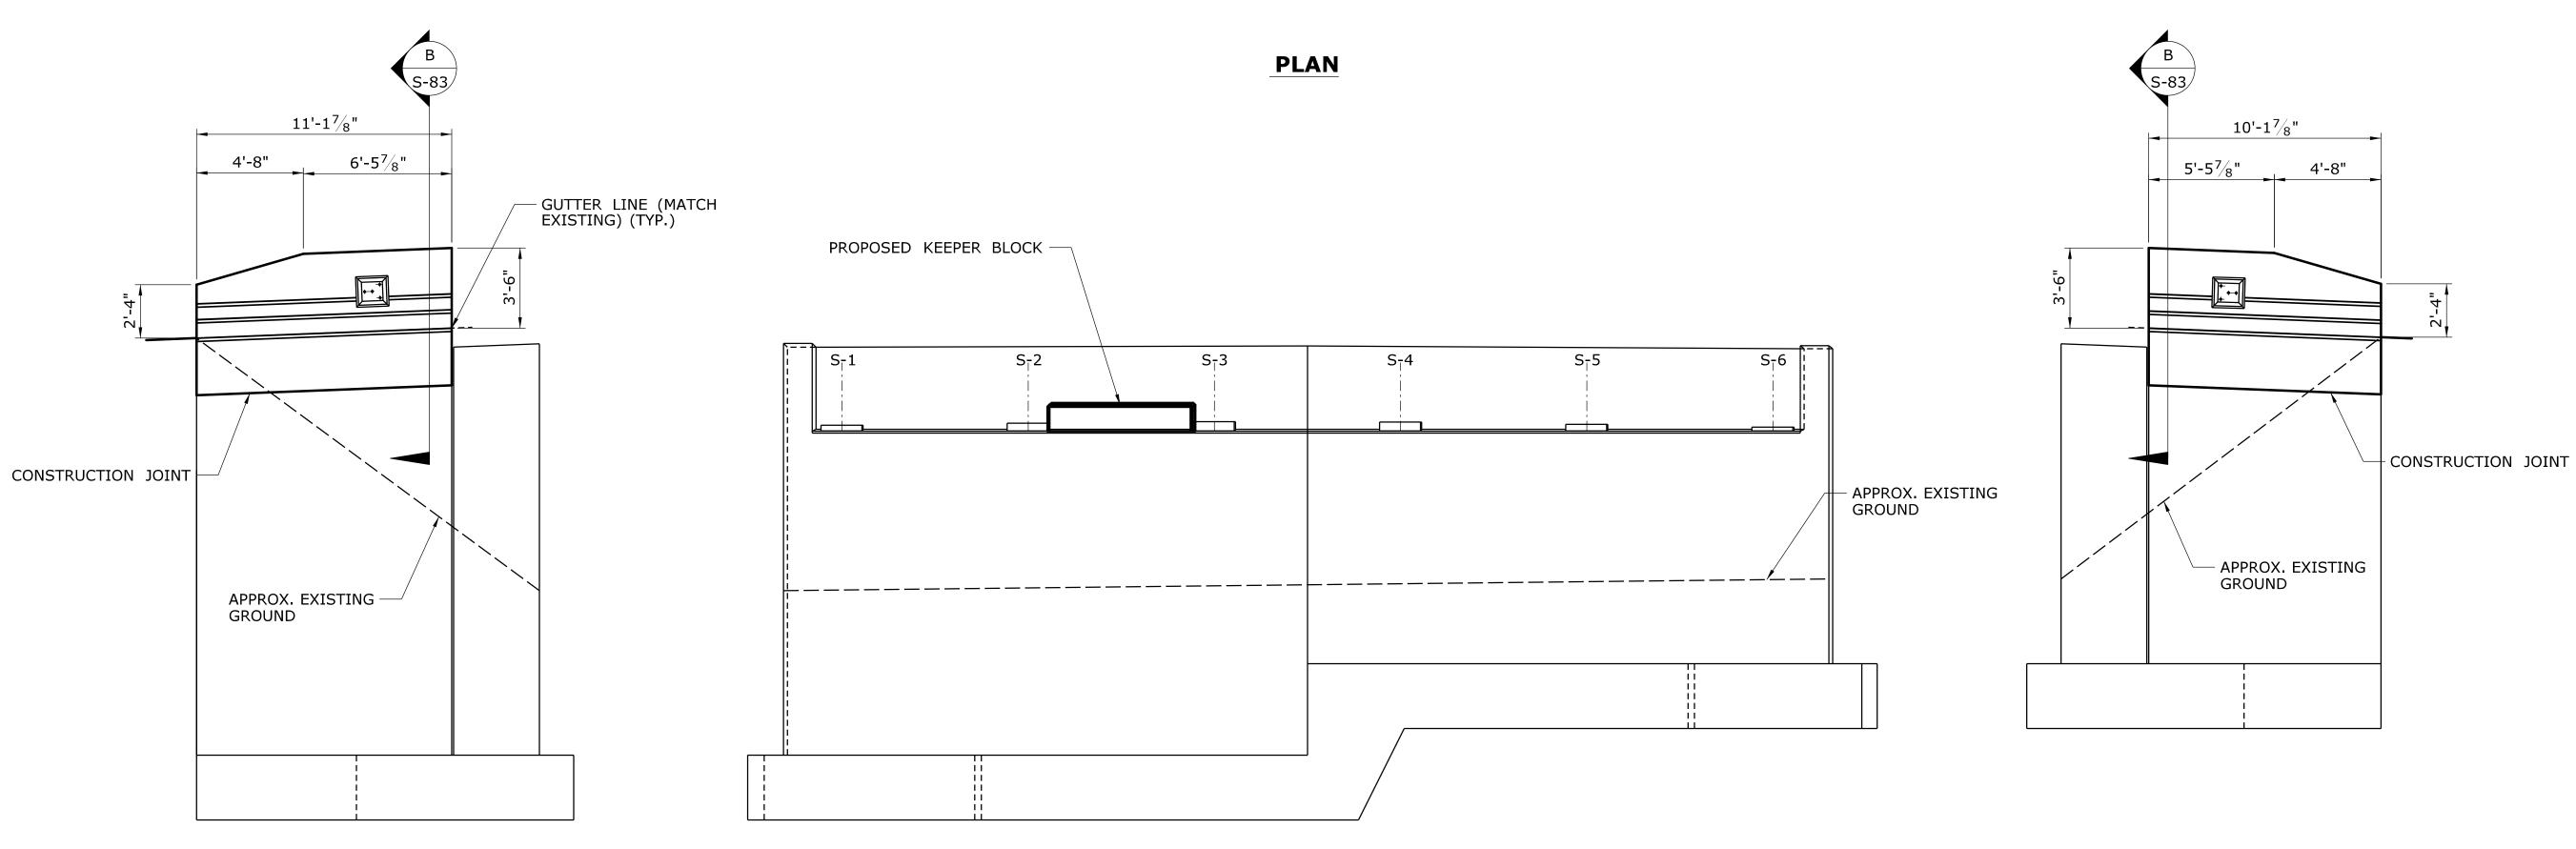
- 1. FOR WINGWALLS MODIFICATION DETAILS, SEE DRAWING NO. S-83.
- 2. FOR PROPOSED KEEPER BLOCK DETAILS, SEE DRAWING NO. S-84.

ELEVATION

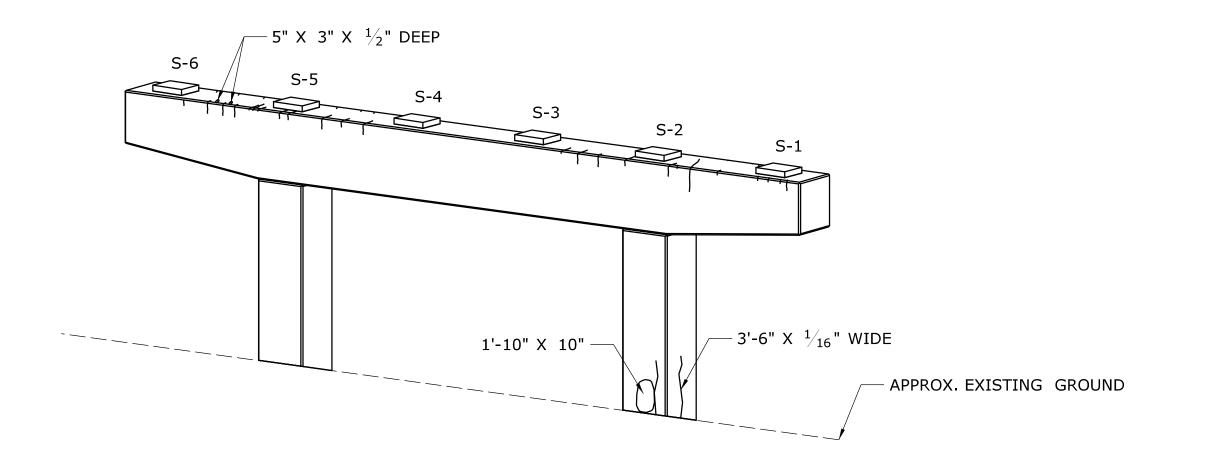
PIER 1, LOOKING NORTH

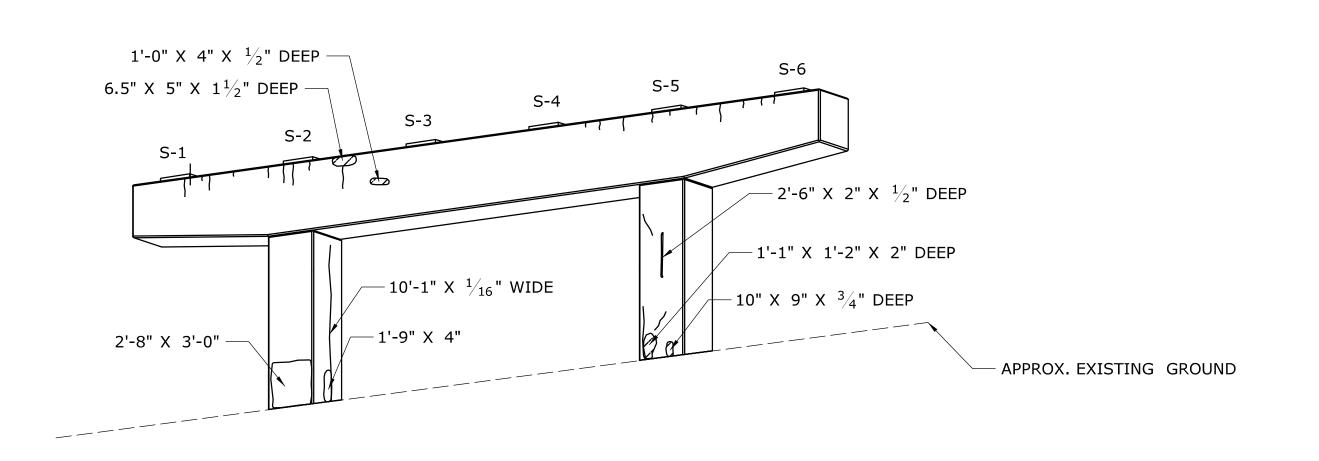
PIER 1, LOOKING SOUTH

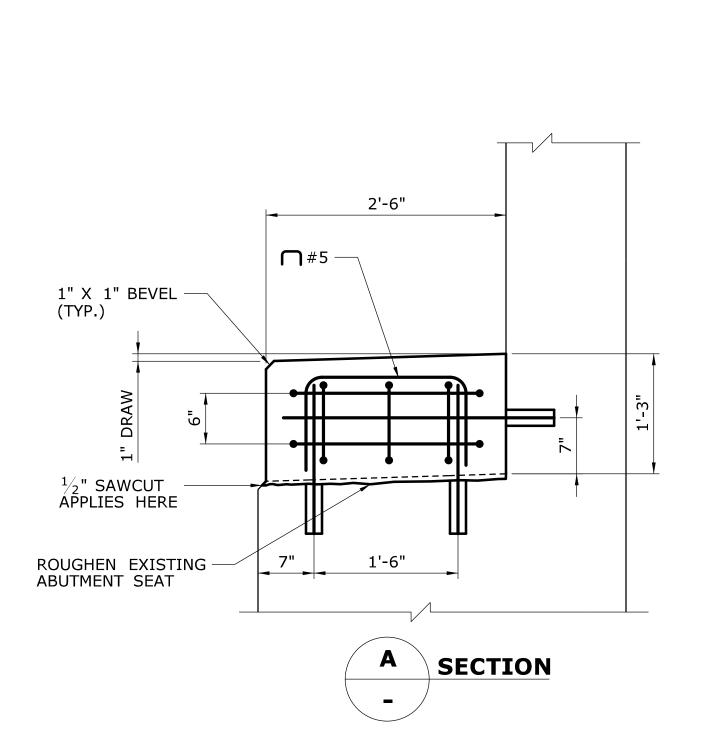
PROPOSED CONCRETE KEEPER BLOCK AT ABUTMENTS

SCALE: 1'' = 1'-0''

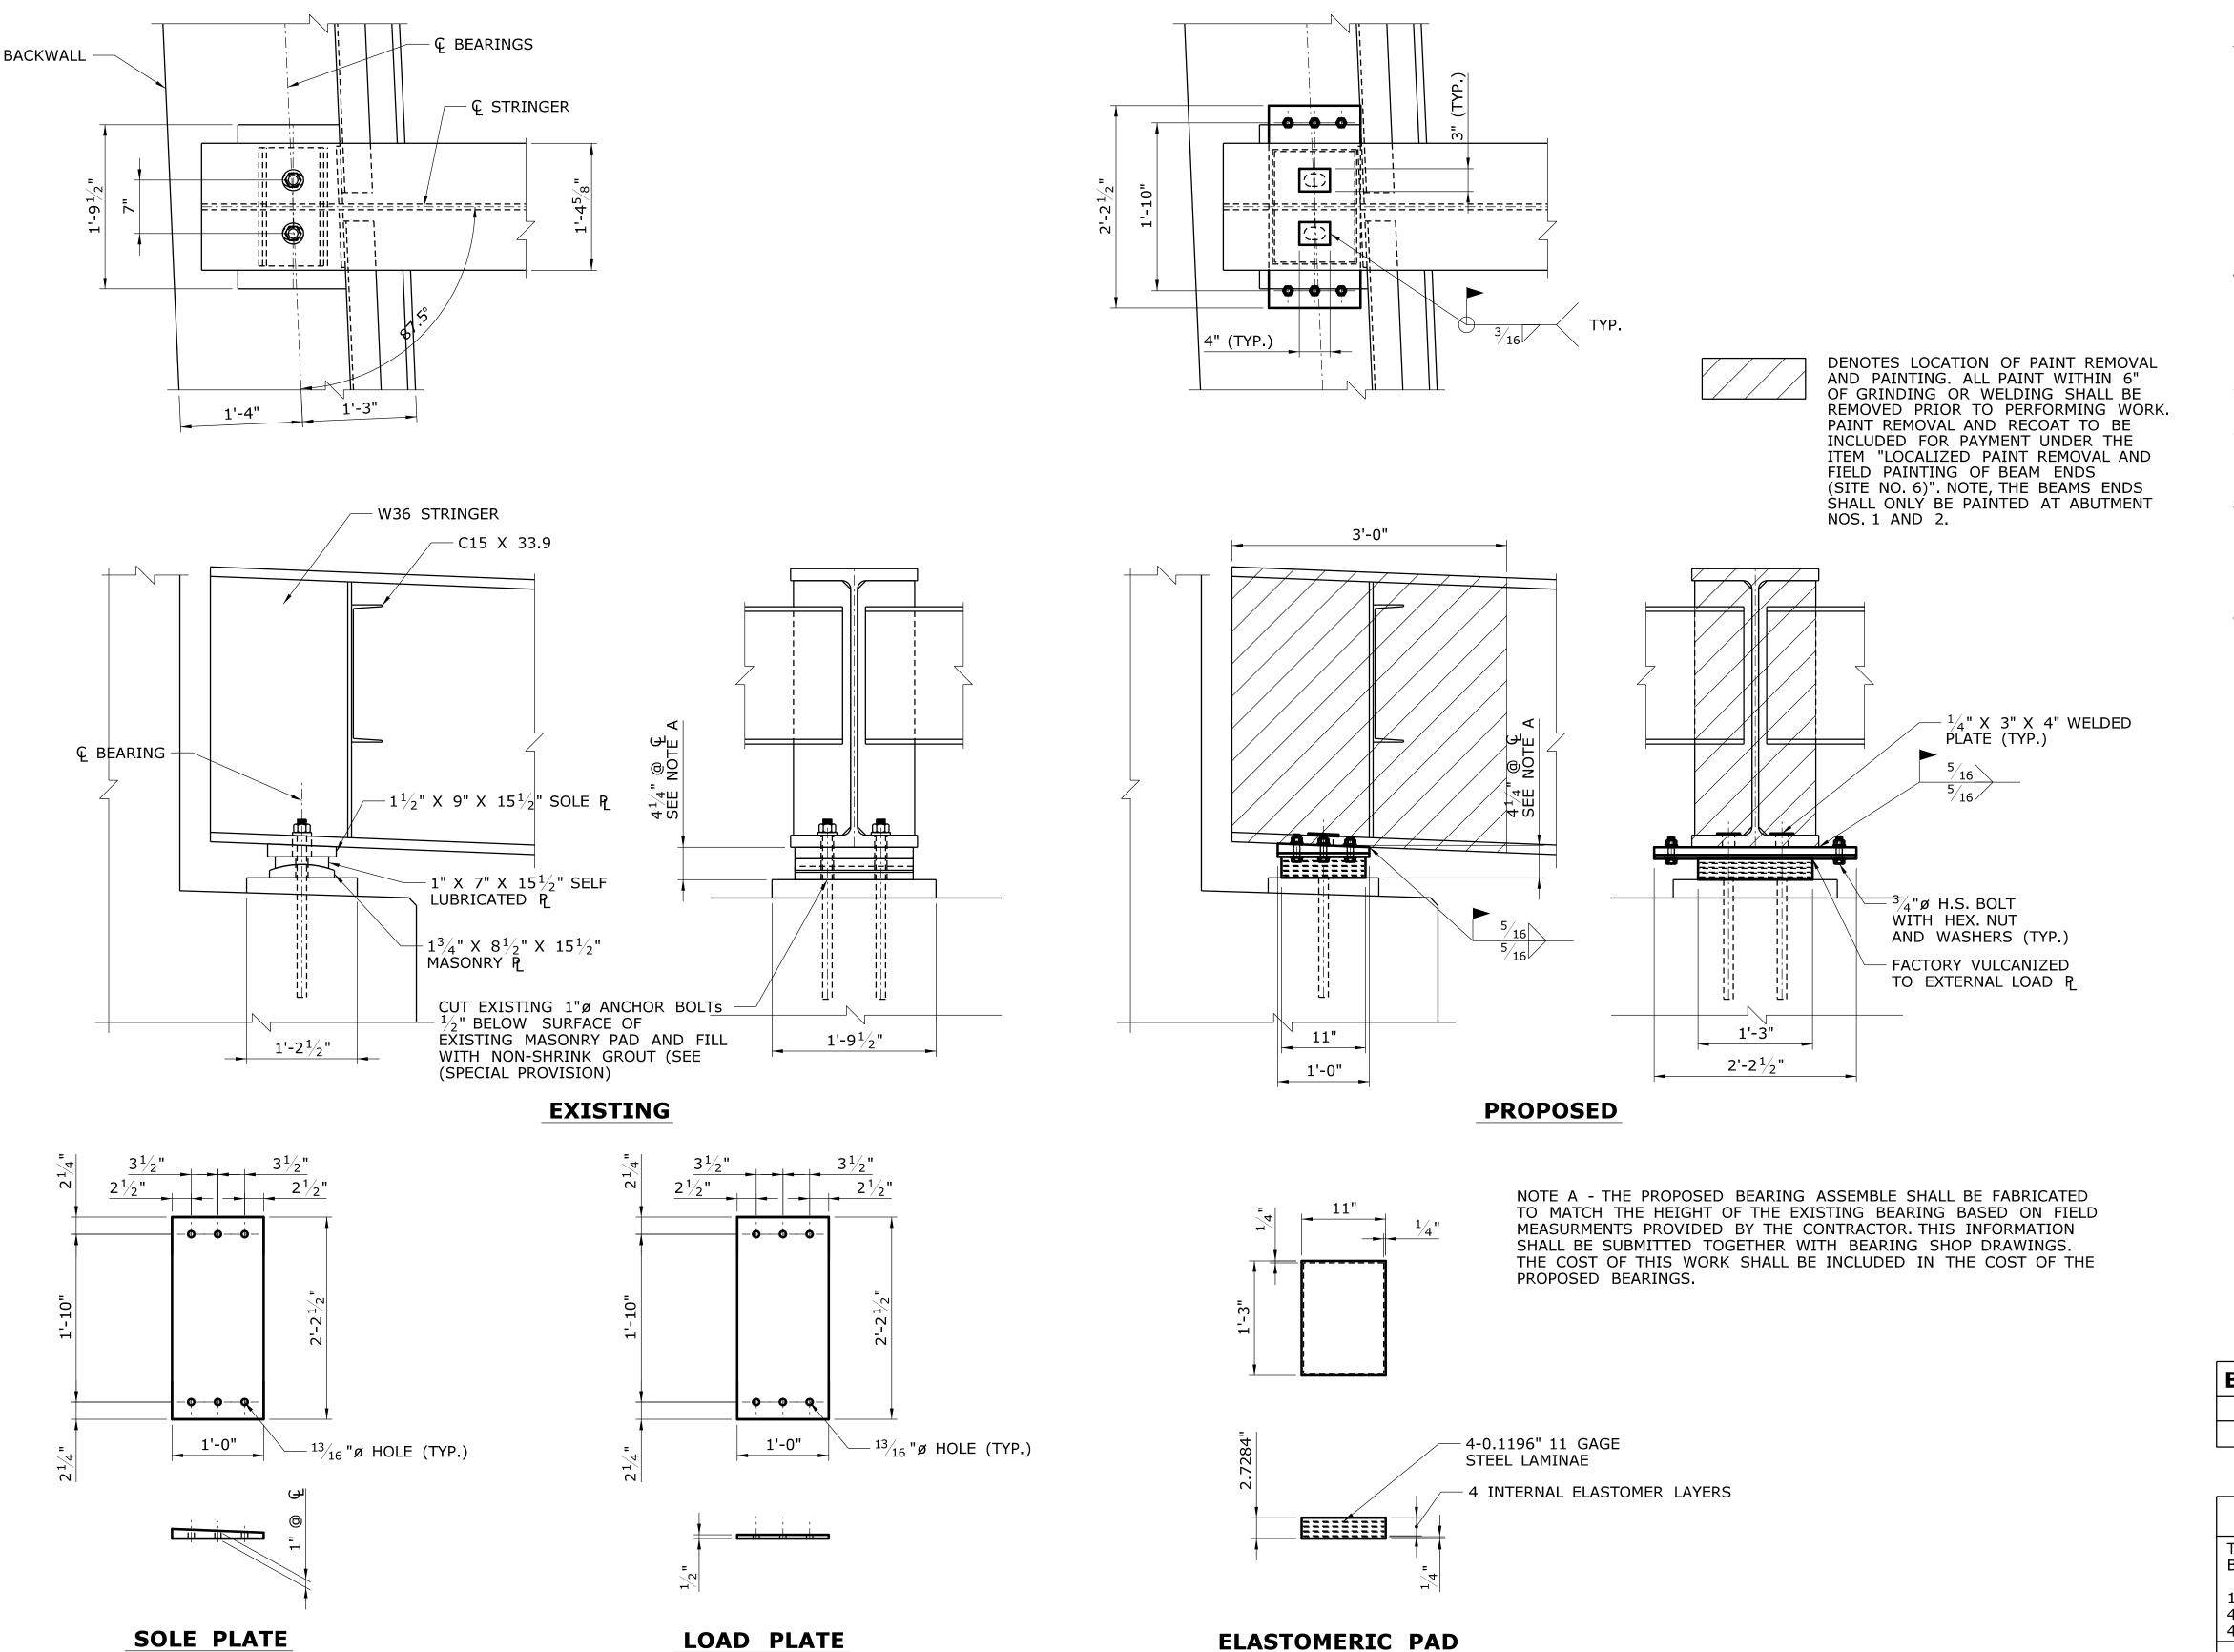
EXPANSION BEARING NOTES:

- PRIOR TO JACKING THE GIRDER FOR BEARING REMOVAL, EXPANSION BEARINGS AND GIRDER SHALL HAVE PAINT REMOVED IN ACCORDANCE WITH THE PLANS, SPECIFICATIONS, OR AS ORDERED BY THE ENGINEER.

- THE HIGH STRENGTH BOLTS SHALL BE $\frac{3}{4}$ " IN DIAMETER AND CONFORM TO ASTM A325, TYPE 1. ALL BOLT HOLES SHALL BE STANDARD HOLES ($\frac{1}{16}$ " LARGER THAN THE BOLT DIAMETER), UNLESS OTHERWISE NOTED, THE NUTS SHALL CONFORM TO ASTM A563, GRADE DH OR DH3. THE WASHERS SHALL CONFORM TO ASTM F436.

- THE LOAD PLATE SHALL BE HOT BONDED TO THE ELASTOMERIC BEARING DURING VULCANIZATION AS SHOWN ON THE PLANS.
- 10. WELDING DETAILS, PROCEDURES AND TESTING METHODS SHALL CONFORM TO THE LATEST ANSI/AASHTO/AWS D1.5 - BRIDGE WELDING CODE, UNLESS OTHERWISE NOTED ON THE PLANS.

- 11. THE EXPOSED SURFACES OF THE ELASTOMER SHALL NOT BE PAINTED
- 12. THE COST OF REMOVING THE EXISTING BEARINGS, FURNISHING, AND INSTALLING THE ELASTOMERIC BEARINGS, INCLUDING THE BEVELED SOLE PLATES, LOAD PLATES, $\frac{1}{4}$ " WELDED PLATE, BOLTS, NUTS, AND WASHERS SHALL BE PAID FOR UNDER THE ITEM "BEARING REPLACEMENT WITH ELASTOMERIC BEARING PADS."

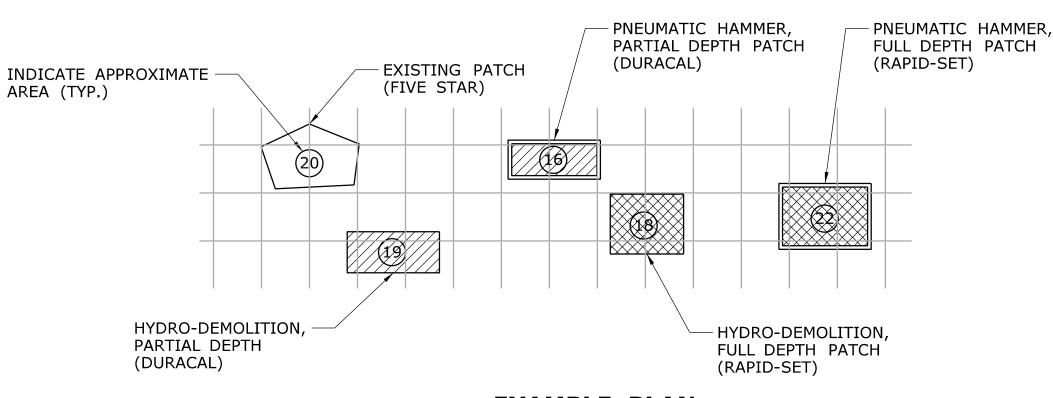
EXAMPLE PLAN

DECK PATCHING LEGEND:

DENOTES THE LIMITS OF REMOVAL BY HYDRO-DEMOLITION, REPLACE WITH PARTIAL DEPTH PATCH.

DENOTES THE LIMITS OF REMOVAL BY PNEUMATIC HAMMER, REPLACE WITH PARTIAL-DEPTH PATCH.

DENOTES THE LIMITS OF REMOVAL OF HYDRO-DEMOLITION, REPLACE WITH FULL DEPTH PATCH.

DENOTES THE LIMITS OF REMOVAL BY PNUEMATIC HAMMER, REPLACE WITH FULL DEPTH PATCH.

- 1. THE BEGINNING AND COMPLETION DATES OF REPAIRS.
- 2. THE LIMITS OF EXISTING AND FINISHED PATCHED DECK AREAS ON THE PLAN USING THE PATTERN SHOWN IN THE DECK PATCHING LEGEND. (SEE EXAMPLE PLAN)
- 3. THE APPROXIMATE PERCENTAGE OF TOTAL DECK AREA REPAIRED WITH PARTIAL AND FULL DEPTH PATCHES.
- 4. THE FINAL QUANTITIES OF PARTIAL AND FULL DEPTH PATCHING MATERIALS USED IN THE DECK REPAIRS.
- 5. THE METHOD AND LIMIT OF REMOVAL OF THE DETERIORATED CONCRETE FOR EXAMPLE PNEUMATIC HAMMER OR HYDRO-DEMOLITION AS INDICATED ON THE DECK PLAN.
- 6. THE BRAND OF PATCHING MATERIAL USED AT EACH LOCATION ON THE DECK (DURACAL, CLASS "F" CONCRETE, ETC.) AS SHOWN IN THE EXAMPLE PLAN.

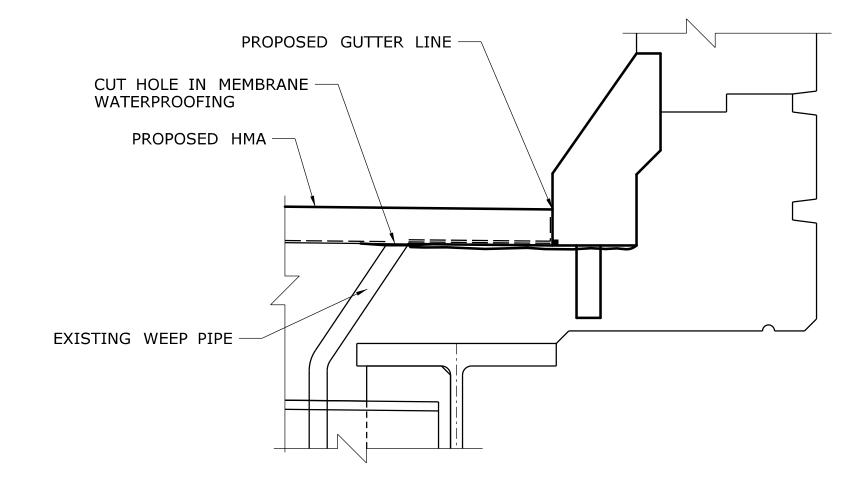
EXISTING

MEMBRANE WATERPROOFING TREATMENT AT GUTTER

SCALE: $1\frac{1}{2}$ " = 1'-0"

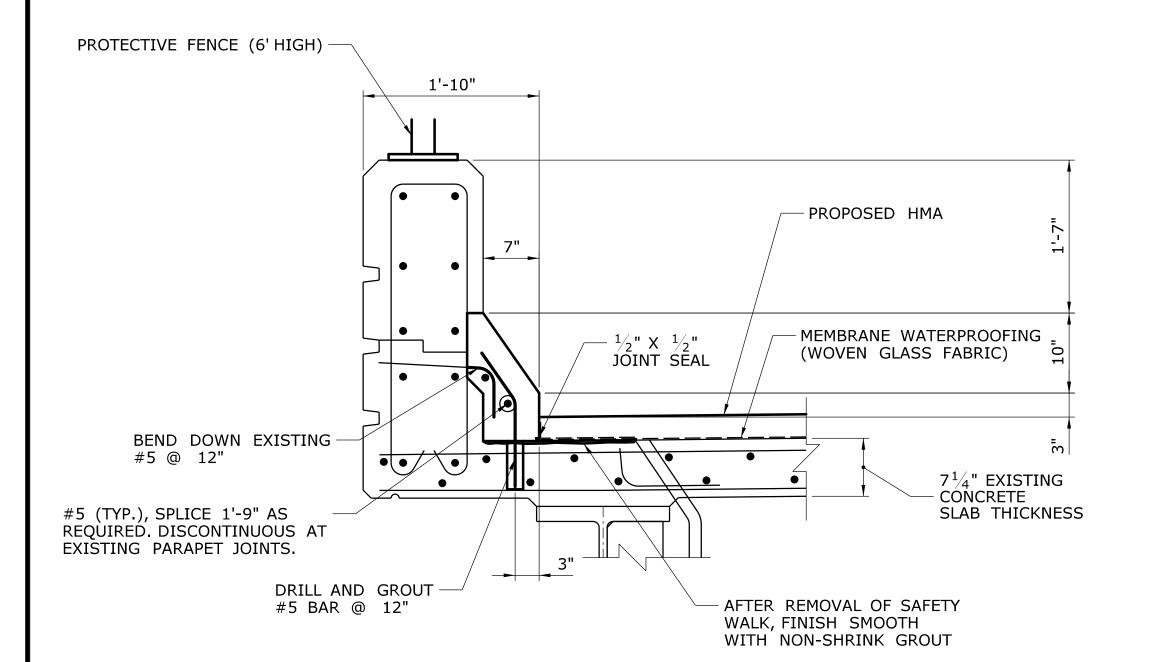
PROPOSED BRIDGE PARAPET MODIFICATION DETAIL

SCALE: 1'' = 1'-0''

- DO NOT DAMAGE EXISTING REINFORCING TO REMAIN DURING THE REMOVAL OPERATIONS.
- ALL EXPOSED REINFORCING INTEGRATED INTO NEW WORK SHALL BE THOROUGHLY CLEANED PRIOR TO PLACEMENT OF NEW CONCRETE.

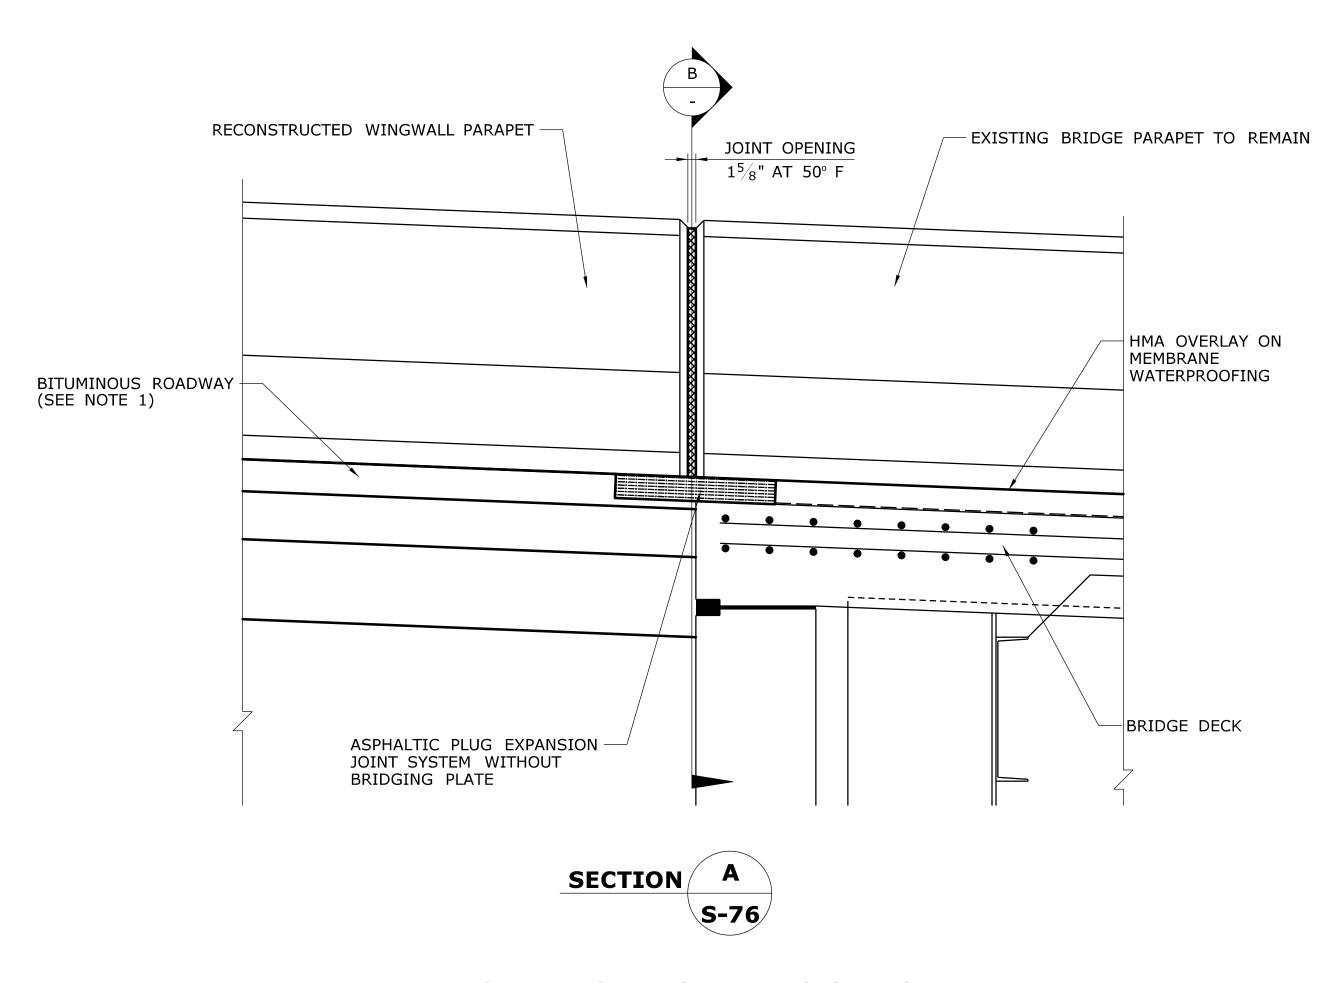
ASPHALTIC PLUG EXPANSION JOINT

SCALE: 1" = 1'-0"

- 8. ASPHALTIC PLUG EXPANSION JOINT SYSTEMS MAY BE INSTALLED ONLY WITHIN THE TEMPERATURE RANGE SPECIFIED IN THE SPECIAL PROVISION "ASPHALTIC PLUG EXPANSION JOINT SYSTEM". REFERENCE THE RANGE OF THERMAL MOVEMENT FOR THE SELECTED JOINT PRODUCT IN THE TABLE FOR "ALLOWABLE BRIDGE SUPERSTRUCTURE SURFACE TEMPERATURE RANGE" IN THE SPECIAL PROVISION.

- 9. SAW-CUTTING AND REMOVAL OF PAVEMENT FOR JOINT INSTALLATION TO BE INCLUDED FOR PAVEMENT UNDER THE ITEM "ASPHALTIC PLUG EXPANSION JOINT SYSTEM".

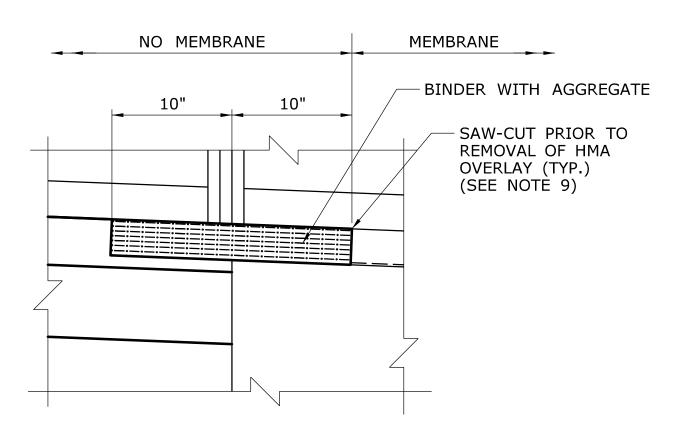
DETAIL

SCALE: $1\frac{1}{2}$ " = 1'-0"

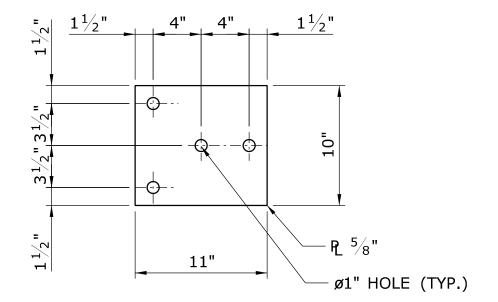
- 1. ANCHOR PLATES SHALL CONFORM TO THE REQUIREMENTS OF ASTM 36. THE ANCHOR PLATES SHALL BE HOT-DIP GALVANIZED IN ACCORDANCE WITH THE REQUIREMENTS OF ASTM A123.
- 2. ANCHOR BOLTS SHALL CONFORM TO THE REQUIREMENTS OF ASTM A325, TYPE 1. THE NUTS SHALL CONFORM TO ASTM 563, GRADE DH. THE WASHERS SHALL CONFORM TO ASTM F436. ALL BOLTS, NUTS AND WASHERS SHALL BE HOT-DIP GALVANIZED IN ACCORDANCE WITH ASTM A153.
- 3. 1" DIAMETER PIPE SHALL CONFORM TO ASTM A53, GRADE B OR ASTM A501 AND SHALL BE GALVANIZED IN ACCORDANCE WITH THE REQUIREMENTS OF ASTM A123.
- 4. ALL RAIL ANCHORAGE MATERIAL REQUIRED FOR END ATTACHMENTS INCLUDING ANCHOR BOLTS, ANCHOR PLATES AND PIPE SLEEVES SHALL BE INCLUDED FOR PAYMENT UNDER THE HIGHWAY ITEM "METAL BEAM RAIL (TYPE R-B 350)".

ANCHOR PLATE DETAIL

SCALE: $1\frac{1}{2}$ " = 1'-0"
